# A Unique Failure Mechanism of a Distal Radius Fracture Fixed with Volar Plating

## A Case Report

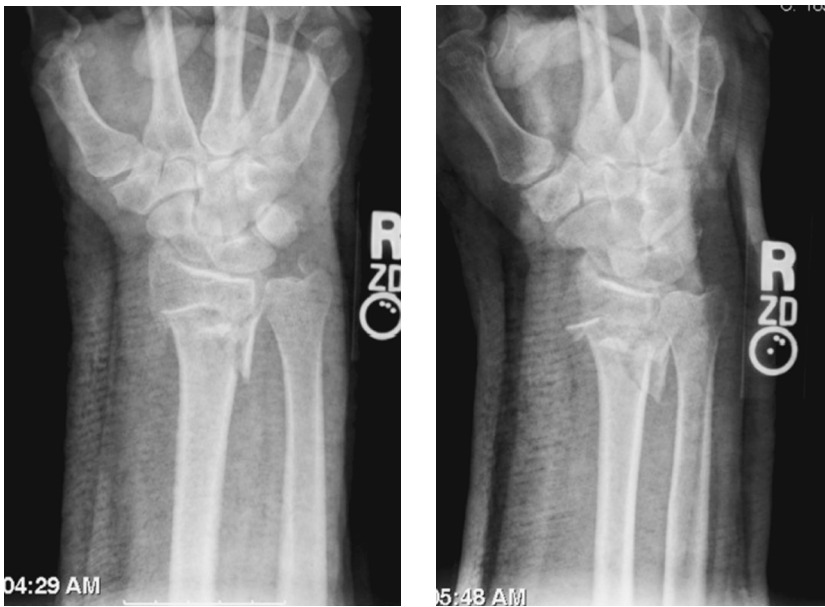
The patient is a 56-year-old right-hand dominant male, with a social history significant for smoking (amount not specified), who sustained a right distal radius fracture after a mechanical fall (Fig. 1). The patient was examined in the emergency department, where a neurovascularly intact right distal radius fracture was noted. He initially underwent closed reduction that subsequently collapsed on follow-up radiographs. The patient was indicated for an open reduction internal fixation (ORIF) of the fracture one and a half weeks status post fall. The fracture was fixed using a volar locking plate (Hand Innovation Plate, Hand Innovations LLC, Miami, Florida) (Fig. 2).

**Figure 1** Initial injury.

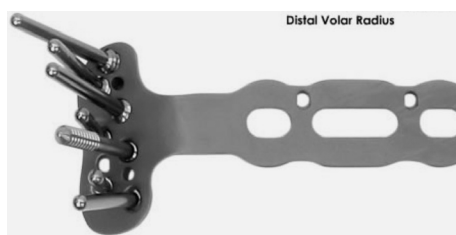
**Figure 2** DePuy Hand Innovation Distal Radius Plate.

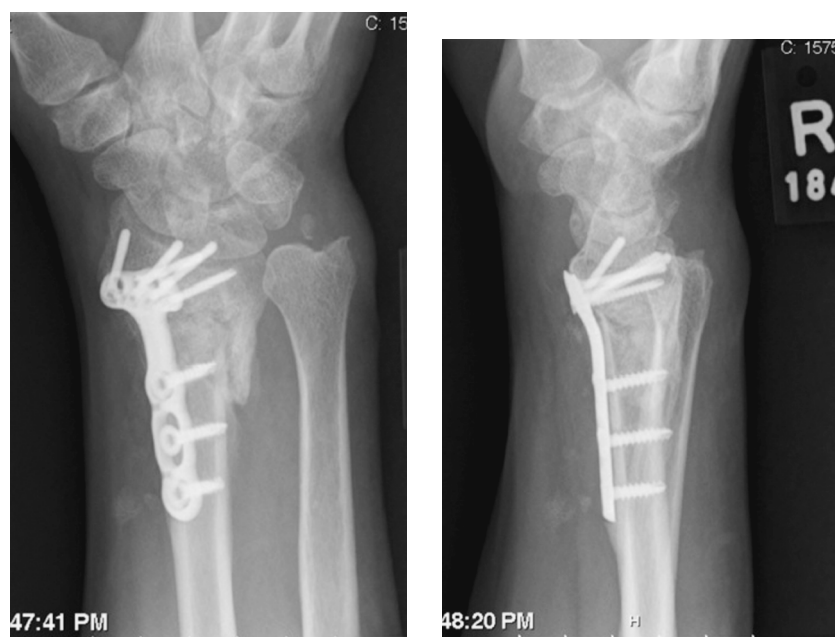
The fracture reduction was maintained at 2 weeks. The patient was lost to follow-up until 3 months later, when he presented complaining of pain over the distal ulna, in addition to a clicking and “popping” in his affected wrist. The patient’s injury remained neurovascularly intact, but radiographic studies revealed distal radioulnar joint separation, with loss of radial height along the ulnar aspect (Fig. 3). Elbow imaging did not reveal any abnormalities. The distal radius fracture appeared healed. No loosening of any of the screws or evidence of a plate failure was noted on radiographs. At this time, the patient was indicated for revision of his initial operative fixation.

**Figure 3** Three weeks status post open reduction and internal fixation surgery.

In our case, we felt that the loss of reduction was a function of the comminution of the fracture. Despite the

fact that the fracture was spanned with a locking plate assembly, it collapsed. This illustrates the need for additional fixation or bone grafting when spanning longer segments. Similar fixation failures, despite adequate fixation spanning, are also noted with internal fixation of proximal tibial fractures.<sup>2,3</sup>

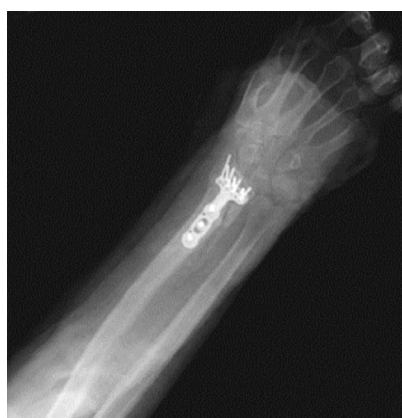
**Figure 4** Revision and revised reduction.

Intraoperatively, the fracture was well healed, and the loss of reduction was noted predominantly along the ulnar aspect of the distal radius. The distal screws were removed, and the

proximal screws were loosened, noting that none of them had come loose. An osteoclysis was performed and the plate was readjusted along the proximal and distal extent. After a reduction was performed, the original plate was reinstalled with tightening of the proximal screws and insertion of distal locking screws. Postoperative and follow-up examinations revealed maintenance of the reduction (Fig. 4).
